## Degradation due to ageing in extraction steam piping of a nuclear power plant

Ageing assessment of extraction steam piping, which was limited to wall loss and corrosion, has been extended to microstructural degradation in this paper. Metallography, radiography, ultrasonic thickness and hardness measurements have been carried out for examining the virgin and twelve years old Seamless Carbon Steel SA 106B pipe in this study. In addition to commonly observed degradation mechanisms i.e. pitting and wall thinning, microstructural degradation has also been observed. The transformation of bands of pearlite and ferrite phases, present in virgin microstructure, into uniformly distributed pearlite and irregularly distribute graphite nodules have been observed due to ageing. The depletion of pearlite phase from 40% to 25% and consequent reduction in hardness up to 20.4% maximum has been observed. The more reduction in hardness of internal surface has been observed as it comes in direct contact with steam. Due to microstructural degradation with simultaneous pitting, wall thinning and reduction in mechanical properties, frequent inspection has been suggested.

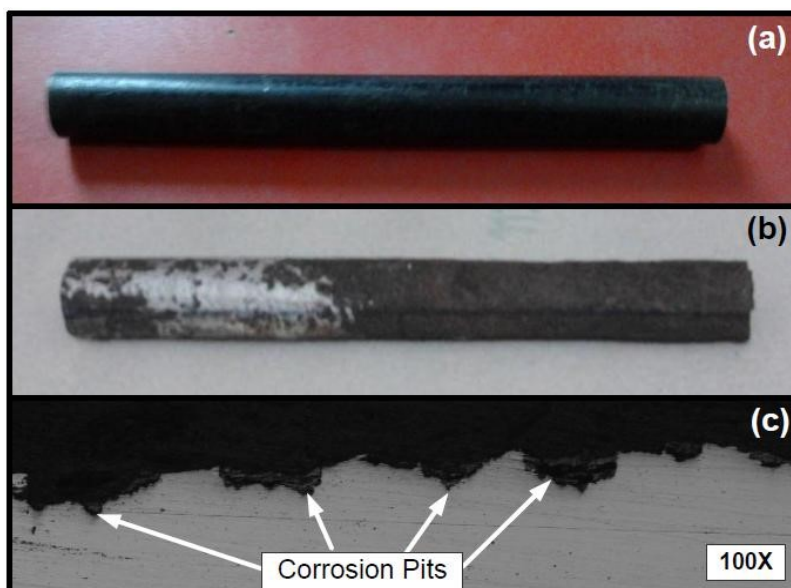
Aged, (c) Cut-off View of External Surface of Aged Pipe Showing Corrosion Pits at 100X magnification.

Visual examination shows no disturbance in uniformity of virgin pipe, See Fig. 2(a). Whereas, aged pipe surface as shown in Fig. 2(b) shows corrosion, as it has been in sea shore environment which is highly corrosive. Corrosion has the potential to reduce a design life of the component by premature degradation (Ginzel, 2002). Examination of corroded surface under metallurgical microscope, as shown in Fig. 2(c), reveals formation of corrosion pits, maximum depth of pit is 0.07 mm, which causes non-uniform reduction in thickness and reduces the ultimate strength of the material (Sidharth, 2009).

**Fig. 2:** SA 106B seamless pipe, (a) virgin, (b)

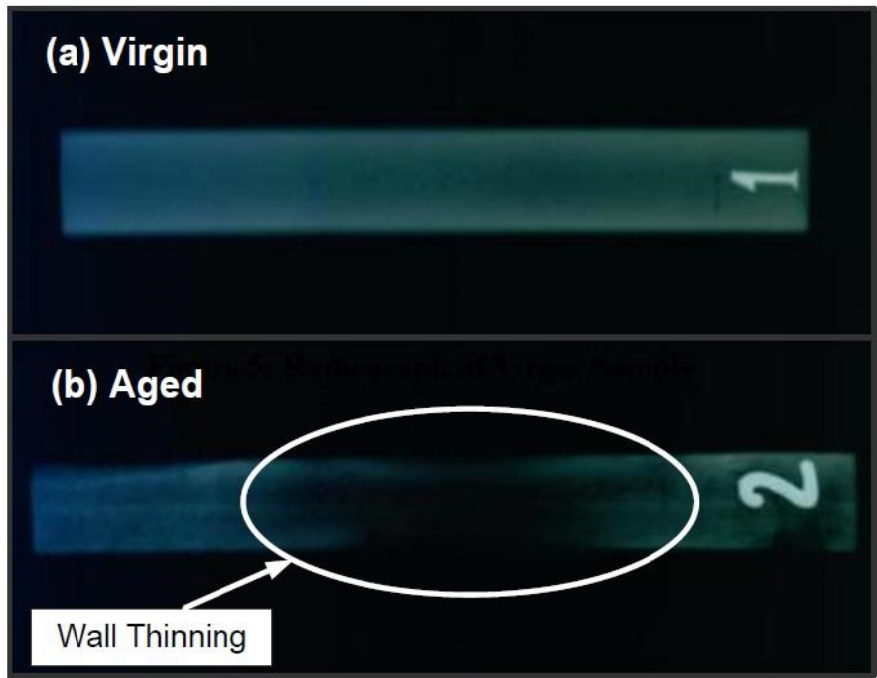
Radiographic examination of virgin pipe exhibits no sign of erosion, as shown in Fig. 3(a). Whereas

material removal is evident on the internal surface of aged pipe, see Fig. 3(b) which shows mechanical

rubbing of steam on internal surface of service exposed pipe (Callister and Rethwisch, 2007). Steam is supplied from middle stage extraction of high

Fig. 3: Radiographs of (a) virgin pipe and (b) aged pipe

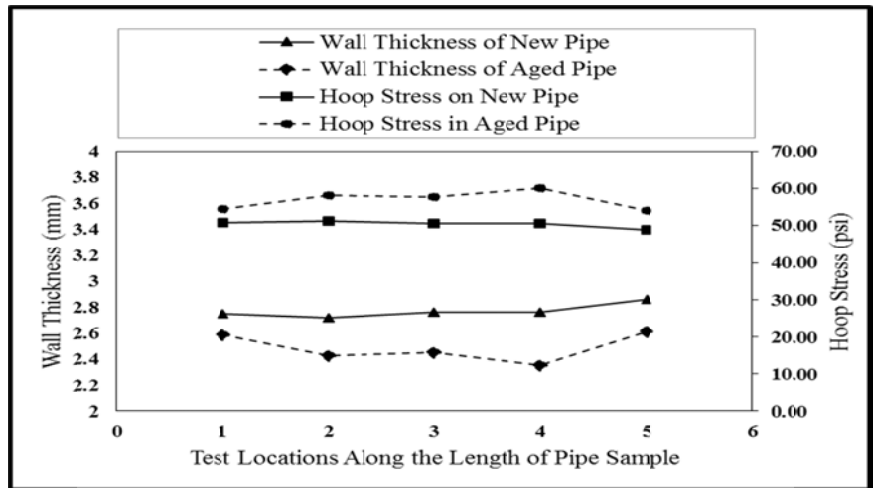
Ultrasonic testing has been performed to determine the intensity of wall thinning due to material removal. On average; 10.46% reduction in thickness is observed from 2.77 mm to 2.48 mm due to 12 years of service. Consequently, the average hoop stress which acts in radial direction because of the pressure inside the pipe and depends upon

thickness of pipe, increases up to 13 % from 50.29 psi to 56.87 psi. As the pipe degrades and thickness reduces, the possibility of pipe failure increases due to increase in hoop stress (Braverman et al., 2005). Fig. 4 shows the increase in hoop stress due to reduction in wall thickness on the pipe.

Fig. 4: Increase in hoop stress due to reduction in wall thickness

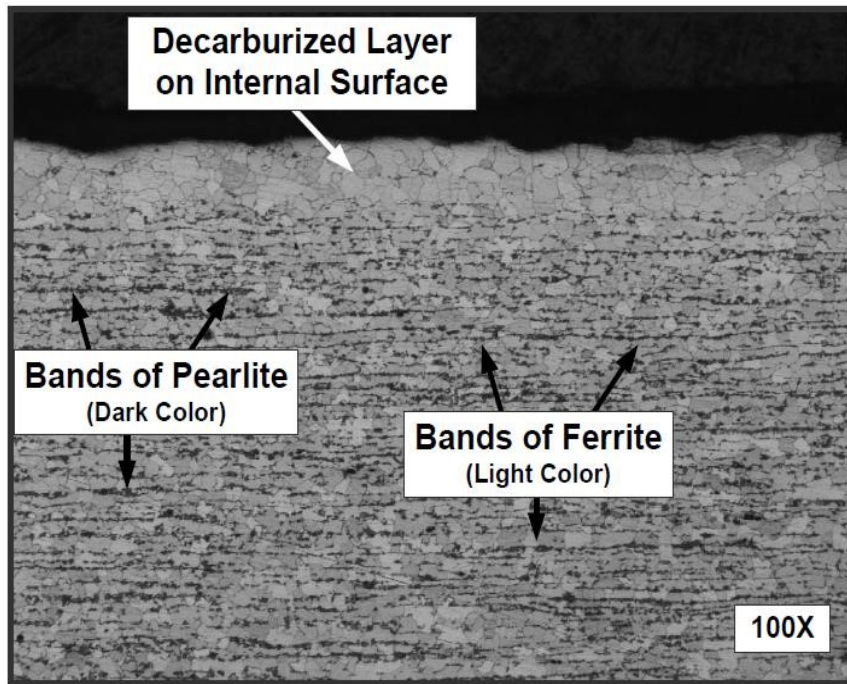
Microstructure of new carbon steel pipe exhibits bands of pearlite and ferrite, see Fig. 5. These bands are typical of the extruded material (Misiolek and Sikka, 2006). Inner surface layer of virgin pipe shows decarburized layer up to 0.1 mm. This decarburized layer forms during cooling of steel to room temperature after hot extrusion (Callister and Rethwisch, 2007) this anisotropic structure shows poor resistance to impact load (Caballero et al., 2006). Abrasive action of steam removes the inner

Fig. 5: Nital (1-10% Nitric Acid in Ethanol) etched microstructure of new seamless SA 106B pipe at 100X

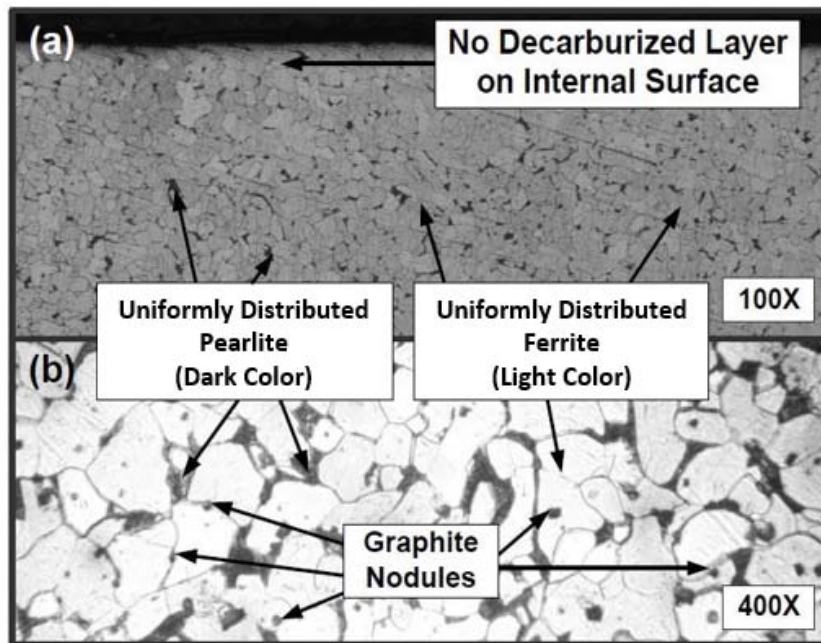
decarburized layer in aged carbon steel pipe. Prolong exposure to high temperature distributes pearlite uniformly throughout the matrix and no bands of pearlite and ferrite are observed in aged pipe, see Fig. 6. Mixture of ferrite and pearlite is more resistant to impact load. Amount of pearlite and ferrite, determined by image analyzing software ImageJ, was 40% and 60% respectively in new carbon steel, which changes to 25% pearlite and 75% ferrite due to twelve years of service in high

temperature and pressure conditions. Reduction in pearlite occurs due to formation of graphite nodules, see Fig. 6 and Table 1. Decreasing amount of pearlite

has deleterious effects as it decreases strength and hardness of steel (Gonzaga et al., 2009).

Fig. 6: Nital etched microstructure of aged seamless SA 106B pipe at (a) 100X and (b) 400X.
